SITE: IDEAL COOPERAGE
DATE: MAY 17-22, 1991
PHOTOS BY: P. DI PASCA (TAT)
PHOTOS BY: 2ND & 3RD WEEKS
DESCRIPTION: OF SITE ACTIVITY
(INCLUDES TEST PITS)

SITE: Ideal Cooperage, Jersey City, NJ DATE: May 17, 1991 PHOTO BY: P. Di Pasca, Weston TAT

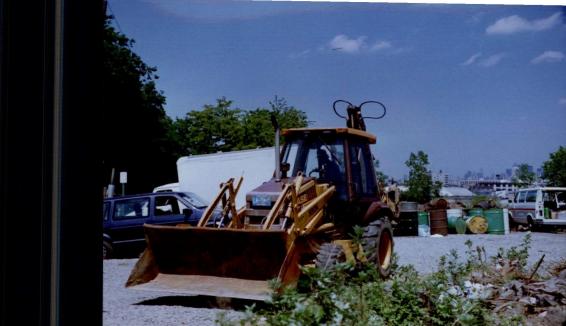
SITE: Ideal Cooperage, Jersey City, NJ
DATE: May 21, 1991
PHOTO BY: P. Di Pasca, Weston TAT
DESCRIPTION: Case 580K backhoe mobilized
to site
